Errors in radiation oncology: a study in pathways and dosimetric impact

Errors in radiation oncology: A study in pathways and dosimetric impact

Eric E. Klein,^a Robert E. Drzymala, James A. Purdy, and Jeff Michalski
*Department of Radiation Oncology, Washington University School of Medicine,
St. Louis, Missouri 63110 U.S.A.
klein@radonc.wustl.edu*

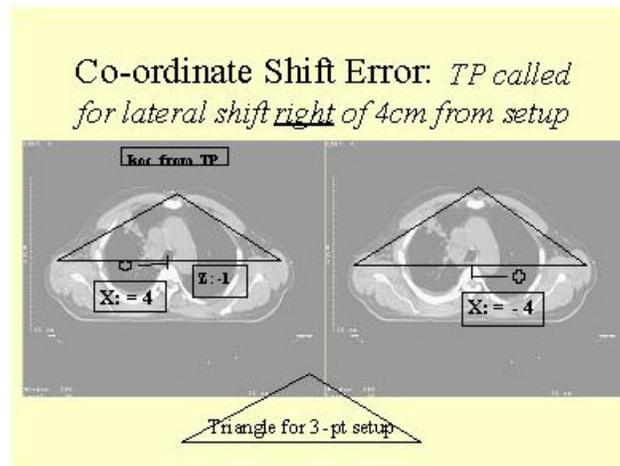
During CT simulation, an initial reference is scribed in image planes denoting a projected isocenter. If subsequent treatment planning requires that the isocenter be placed 4.0 cm to the patient's left, requiring a need to shift the table lateral coordinates +4.0 cm, this will lead to the table coordinates to be used for treatments. However, due to a misinterpretation, a value of -4.0 cm could be used to determine the lateral table coordinate.

Fig. 1. Visual description of how a coordinate shift error, in this case a lateral shift of -4 cm instead of the planned $+4$ cm, would result in an incorrect isocenter placement.

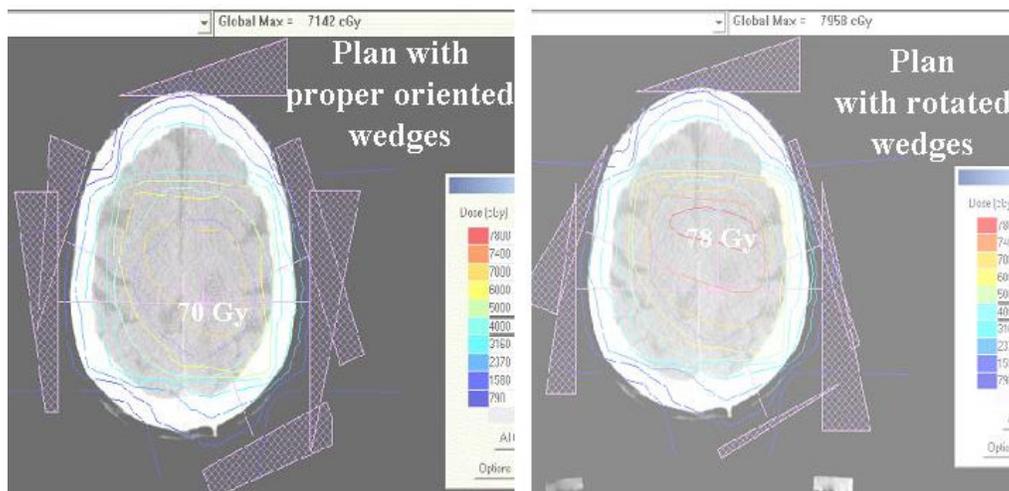
An additional problem with this type of virtual wedging is that the nomenclature used by treatment-planning systems is not intuitive and not necessarily correlated to the nomenclature used by the treatment machines and/or R&V systems. Therefore, a misappropriated wedge direction could possibly go undetected by physics checks and by therapists on the first day of treatment. Unfortunately, *in vivo* dosimetry performed with a diode on central axis will not catch this particular error. Although we had the therapists check the final jaw position at the end of treatment (indicating the “toe” of the wedge), this policy was not carried out sufficiently to catch these errors. For the scenario described, the dosimetric error could be as high as 80% to a point 8 cm off-axis, for opposed 60° wedged fields. We found this type of error occurred when the wedge orientation was not obvious in a 2D representation of the treatment, as is the case for central nervous system treatments requiring nonaxial fields. An example of a hypothetical intra-cranial treatment with incorrect wedge directions is seen in Fig. 2. In this case, there are a total of seven beams for which the wedge was reversed from the intended orientations for four of the seven beams. This would have resulted in an increased high dose region (7800 cGy) outside of the tumor volume as compared with 7000 cGy in the correct plan.

Fig. 2. Comparison of isodoses for a central nervous system treatment plan that had called for seven wedged fields. The isodose map on the right demonstrates the resultant isodoses if the wedge orientation was reversed for four of the seven fields. The original plan used 6 MV photons with a target dose of 7000 cGy.

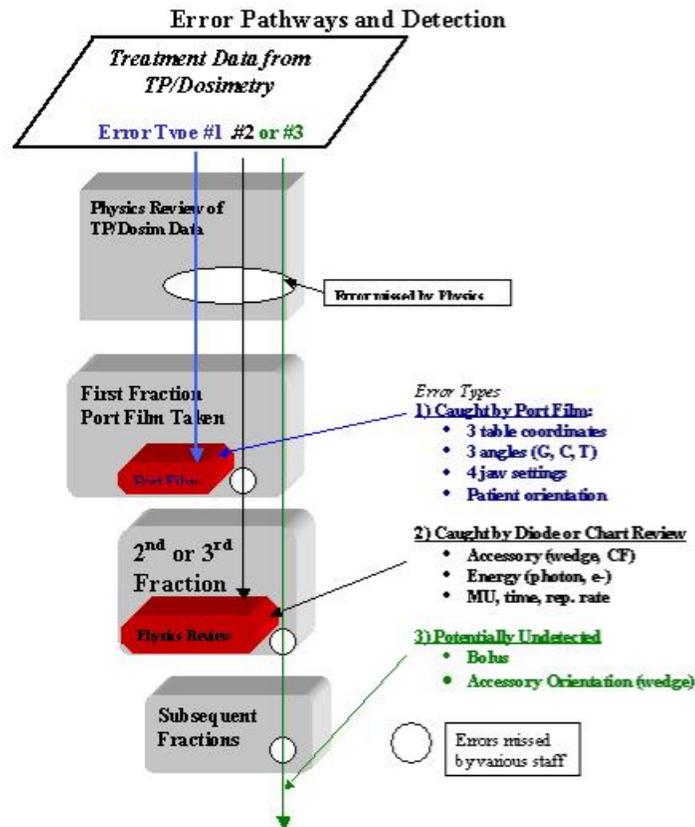
Fig. 3. Flowchart of various error types. (1) Caught by port film review; (2) caught by chart and/or diode review; and (3) potentially undetected, and how the processes either stop or miss such errors.

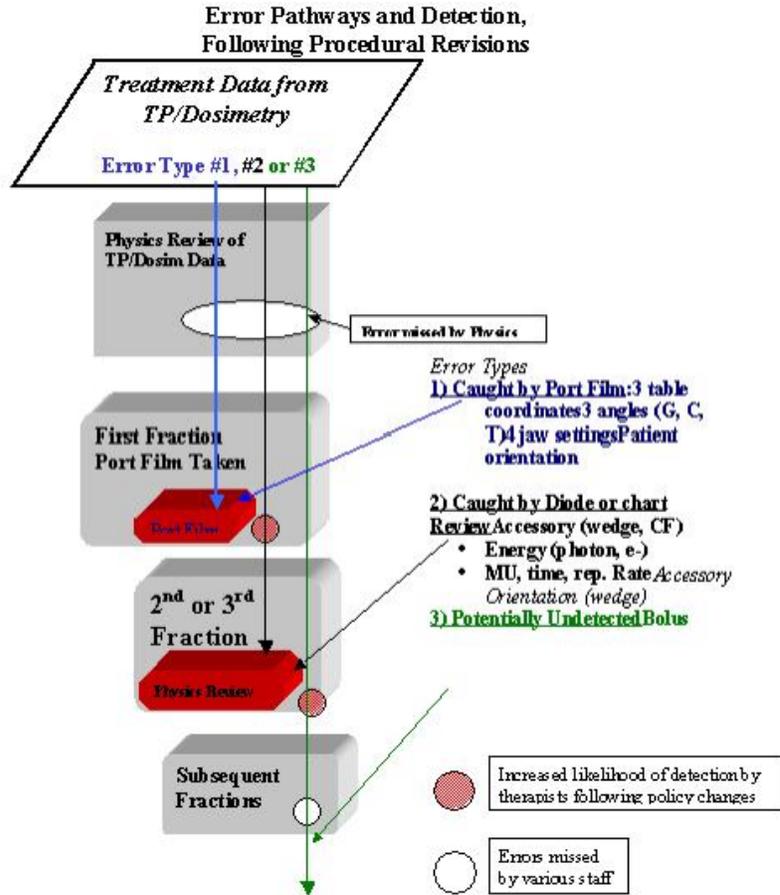
Fig. 4. Flowchart of the same error types following changes made to policies and procedures, whereby certain errors were stopped earlier or were hampered from progressing.

A revised error pathway chart (Fig. 4) demonstrates how some of these changes have altered potential paths. For example, by performing in vivo dosimetry off-axis rather than on central axis, we essentially closed the pathway for the error to propagate beyond the second fraction, thereby reducing the longevity from high to medium.

2. To reduce the likelihood of the infrequent (low frequency) but dosimetrically significant error (high dosimetric impact and high longevity) of an incorrectly oriented accessory (wedge or compensation filter), our policy was changed to require diodes be placed off-axis. This action requires the therapists to place the diode at a known distance off-axis, at a known SSD. The therapist records the direction off-axis relative to patient (e.g., anterior, superior, lateral). When the diode readings are reviewed, corrections are made for the off-axis accessory transmission. Since this change was
